Project work

Evaluation of ecological sanitation pilot facilities in Senegal and Mali

Background of this study thesis was the evaluation of ecological sanitation plants in urban Senegal and semi-urban Mali. In Yoff (Senegal) the pilot station was built in the year 1999 by an local organisation called APECSY which is trying to create an sustainable urban district. The ecosan toilet which is working on the composting process also diverts the urine from the faeces. Here the urine is lead together with the washing water into a reed bed and finally used for watering a garden area.

In Koulikoro (Mali) seven ecosan stations were built by the GTZ in the years 2000-2001 which base on the dehydration and urine separation process. As special feature the urine is lead together with the washing water into a wastewater garden basin by subsurface irrigation pipes.

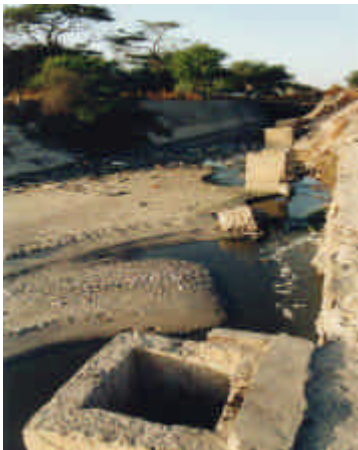
Figure 1-4: Sewage lead into the ocean

In the table 1-1 above it seems that there are only few problems with the sanitation in urban areas in Senegal and Mali (94% and 93%). But even when the sanitation coverage percentage is high there is a lack of proper sanitation or the eventual disposal of sewage respectively. In Dakar which is a city of nearly 2.5 Million inhabitants the central sewage treatment plant purifies only around 14.000 m³ per day; most of the sewage is discharged directly into the sea by open channels. (see figure 1 -4)

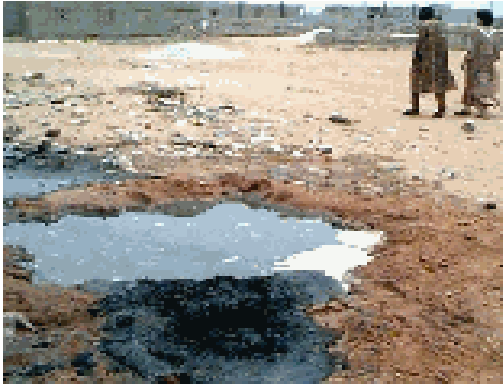
For the desludging process of the septic tanks a vehicle pumps out the contents to bring them to the sewage treatment plant for purification. This normally not happens but the sewage is lead directly into the sea, a hole is dug at the beach or in the road during the night into which the sewage is emptied (see figure 1-5 and 1-6).

Figure 1-5: Sewage dump at the beach

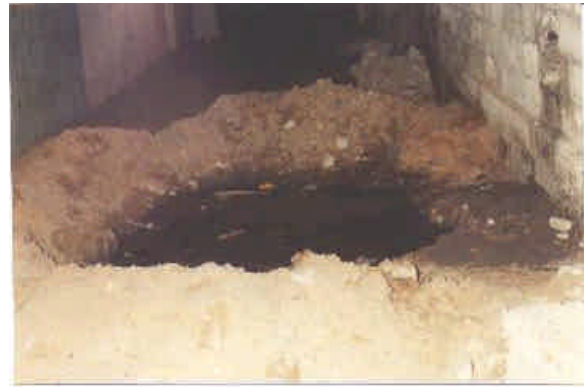
Figure 1-6: Sewage hole in the road

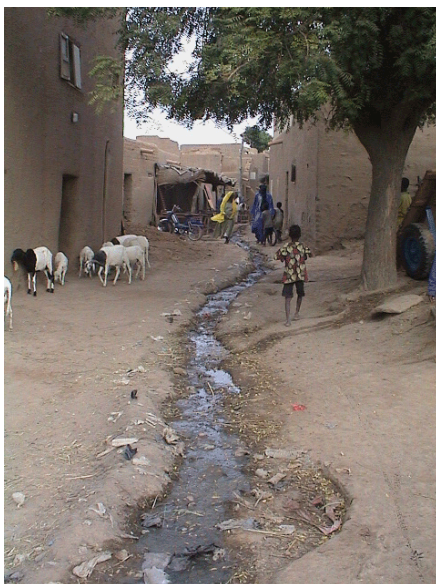
In rural areas in Mali it is nearly the same situation as in Senegal with the difference that in larger cities like Bamako open drainage channels are common. These drainage channels often are blocked with rubbish and other material leading to standing sewage in the system.

Figure 1-7: Drainage on the street in rural Mali

In rural areas pit latrines are common but open defecation also takes place in more poor regions. Household water and overflowing latrines like in figure 1-7 can be seen in all rural areas. These waters pose health risks especially for children playing in them and are leading to the deterioration of living standards for the population.

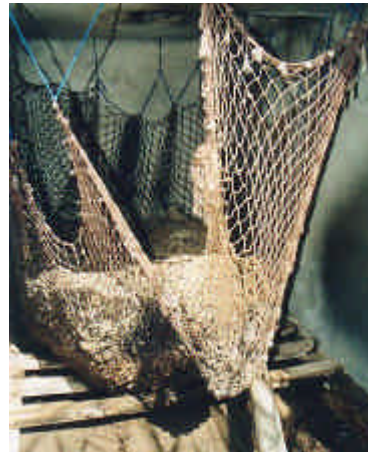
Figure 2-1b: Photo of toilet composting chamber

The toilet which is working on the composting process (see figure 2-1 and 2-1b) was designed for a family with approximately 18-20 members (father, 2 wives, 15 children). The system as shown in figure 2-2a to 2-2c is a double-vault solar heated toilet with an attached reed bed wastewater treatment basin.

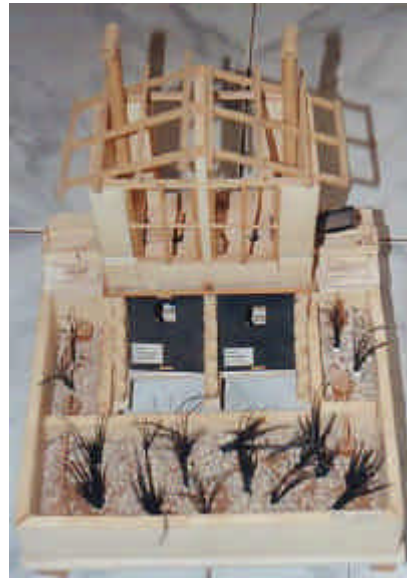
Figure 2-2b: Model of the ecosan system in Yoff

As can be seen in figure 2-2b in each basin are two perforated buckets lined with a cloth to maintain the water level in the basins and to protect the connecting pipes and the gravel from clogging.

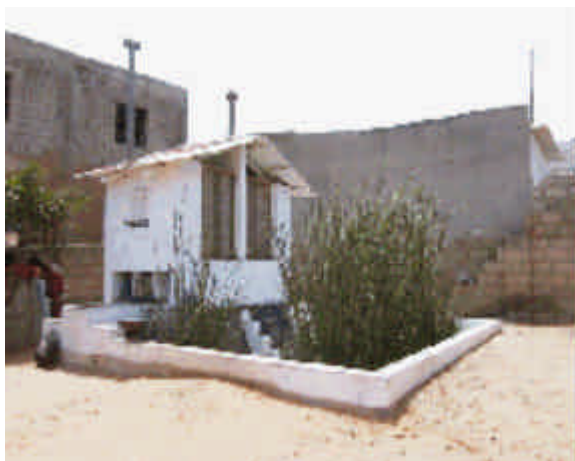
Figure 2-2c: Photo of the ecosan system in Yoff

The structure is constructed on-site of concrete bricks , coated with plaster and later coated with waterproofing liquid to guarantee watertight basins . A strong concret mix (high proportion of cement) is recommended.

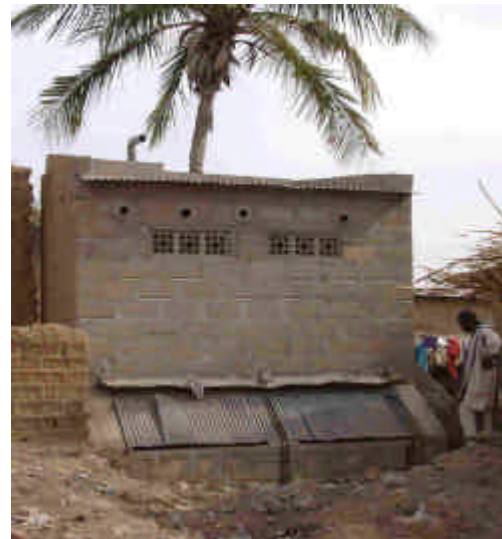
Figure 2-4: Photo of an ecosan dehydration toilet in Koulikoro

Two ecosan toilets in Koulikoro are based on the dehydration or dessication process which is illustrated in figure 2-3 and 2-4 and described in chapter 1.5.1.1 "Ecosan toilets based on dehydration". While the other five installations have normal pit latrines with urine diversion only. They were designed to serve a family with approximately 15-25 persons.

The operation of all three is the same independent of ecosan toilet or pit latrine. The urine is diverted from the faeces and is led together with the washing water into a decanter passing a first metal screen to retain sand, fabrics and other materials. Then it flows through a gravel-charcoal filter and eventually via pipes in the wastewater garden where it simultaneously serves as irrigation water and fertilizer for the plants. The ecosan dessication vaults have metal lids which are painted black in order to absorb the sun's energy and assist the dehydration process.

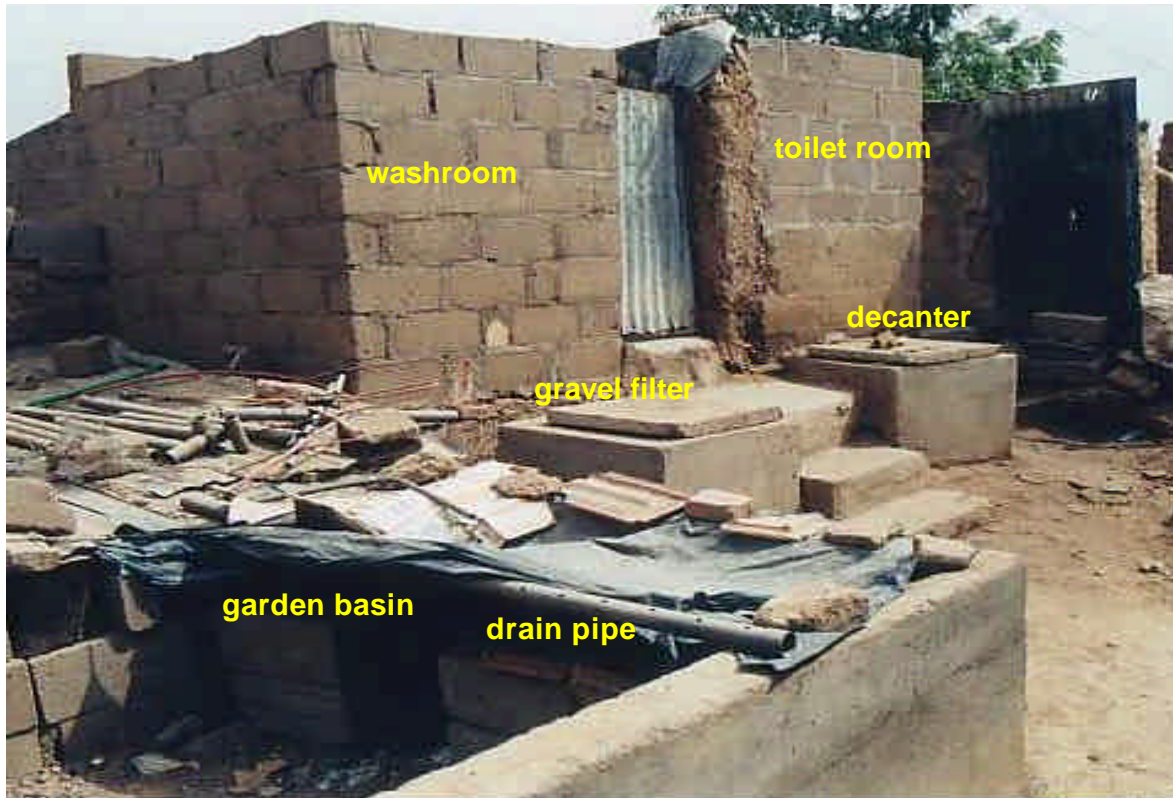
Figure 2-5: Photo of a complete ecosan station

The two ecosan toilets were constructed completely new whereas the other five existing toilets with pit latrines were just modified to fit the new conditions. The basis of the ecosan toilets was made out of natural stones and cement. At one toilet even the decanter and filter unit were fabricated in this way. This construction technique was applied in order to work with locally available material and to save money because the cement in Mali is very costly. The upper part of the toilets as can be seen above is constructed of sun-dried cement stones. Another thing in which the toilets are different are the roofs. One ecosan toilet is equipped with a roof and the rest out of financial and reasons not. Also it is not common for a toilet in this region to have a roof.

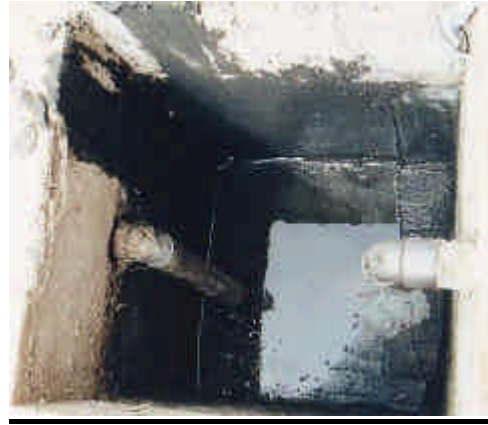
Figure 2-8: Top view into a decanter (outflow pipe on the left is partly missing)

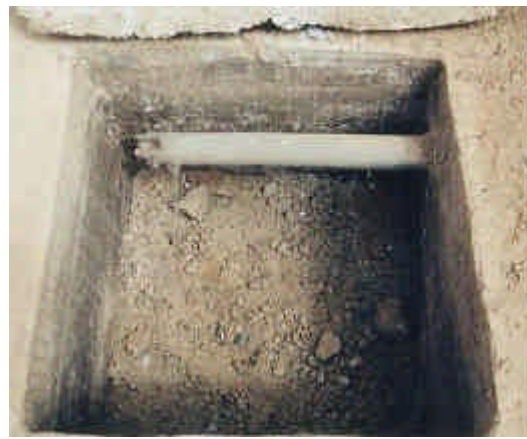
Figure 2-10: Top view of the filter unit

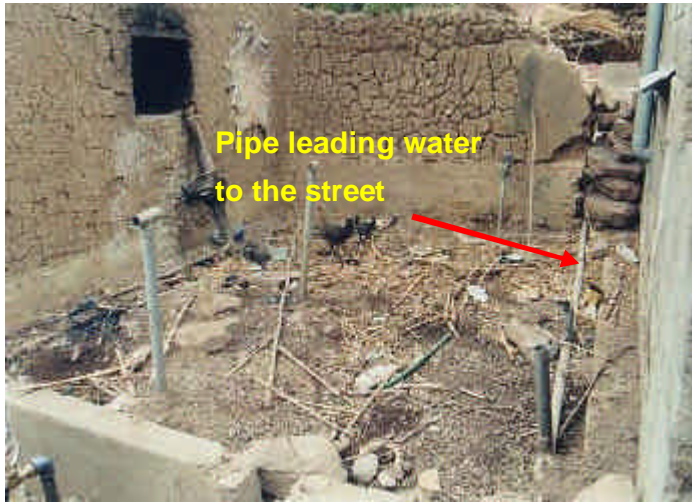
In the figure below the condition of the wastewater garden is shown which is not in use any longer because of clogged irrigation pipes. Now the water is lead directly into the street like before the construction was built. This is the result of a number of circumstances, listed below:

1. The corrosion of the first metal screen in the toilet or washroom lead to a narrowing of the holes and an eventually blocking of the screen. The screen was then stabbed enabling the flux of disruptive material e.g. sand, hairs and residues of the natural sponges into the decanter.
2. This material in the decanter was settling or floating on the water surface (see figure 2-12). After some time the vertical pipes in the decanter were removed because of the foreign material clogging them. This made it possible for fabrics and other material to enter the gravel filter especially when the pipe was removed because it was plugged.
3. After some time of operation the pores but especially the surface of the gravel filter got clogged and water was standing in the filter or was overflowing.
4. Due to the overflowing gravel filter the gravel was removed in order to solve the problem.

These four steps lead to the plugging of the irrigation pipes.

Figure 2-11: Photo of wastewater garden

Another thing which is connected to the failure of the wastewater garden is the missing fence. Due to this reason the animals (chickens and goats) which live on the property eat the plants especially the young ones. As a result there is no vegetation thus no benefits for the family what makes them care about the well function of their garden.

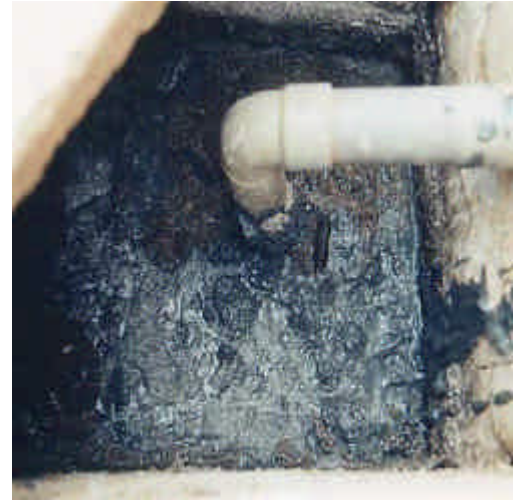
Figure 2-12: Top view of decanter with floating material

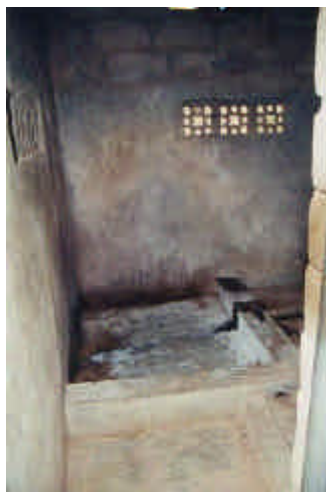
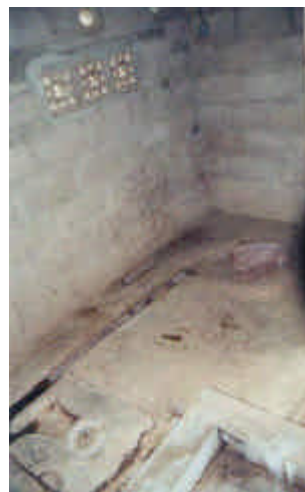
The pictures below give an insight into the toilet and washroom. In this installation the two toilet holes and the shower basin are placed in one room. This leads to the problem that only one person at the same time can use the shower or the toilet. A wall separating the toilet holes from the washroom would lead to an improved situation. Another disruptive element is the missing door which creates a lack of privacy even though the entrance is chosen in that way that it blocks any view. A fault which was done in the planning was the wrong placing of the toilet holes respectively the construction of the foot-rest and urine channels. When using the toilet one is facing the wall directly in front thus turning the back against the entrance. This is controversial to the normal human behavior.

Figure 2-13a and 2-13b: Photos of toilet and shower room

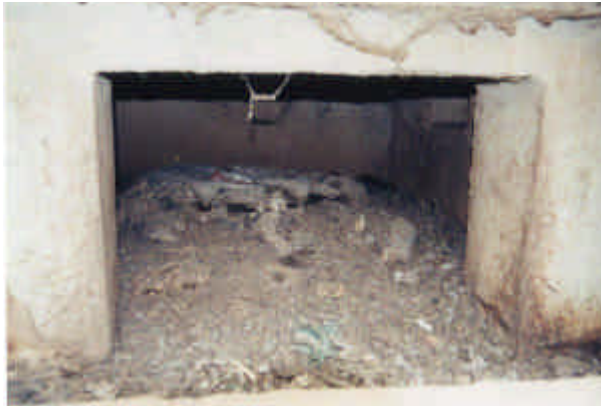
1. The decanter and former gravel filter (the gravel was removed because it was clogged) which are filled with water are leaking through the wall into the desiccation vault.

Due to these reasons a dessication in the chamber is not longer possible. One result of this situation is the bad smell of the wet faeces when it becomes warm.

Figure 2-14: Unused dessication chamber filled with faeces

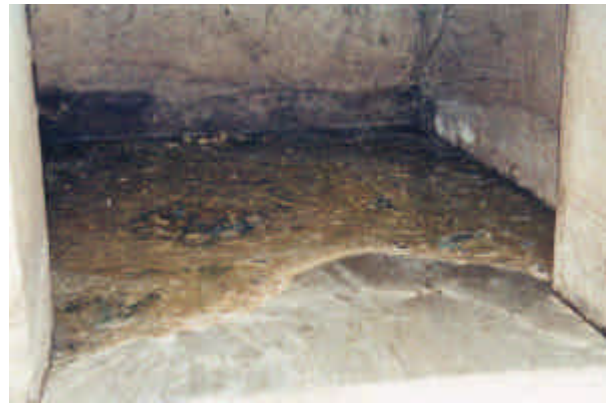
Figure 2-15: Used dessication chamber filled with water and faeces

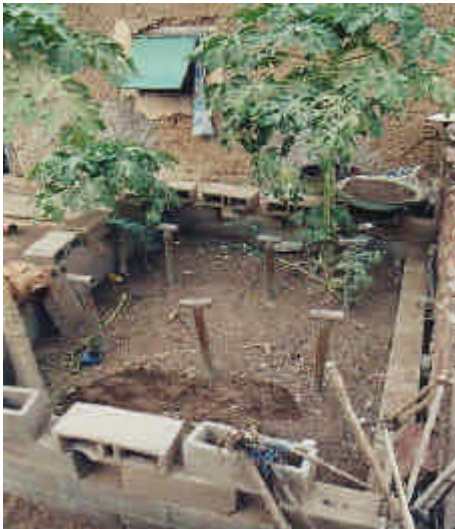
On the left the waste water garden which is only 5.6m² in size with the ventilation pipes can be seen. In average the family uses 300 liter of water per day which results in a surface load of 53.6 l/m². In late January when the picture was taken only Papaya trees could be found. Normally the family also plants Ladyfinger, Tomatoes, Chillies and Dah which grow very well. However they are not planting in the dry season because the watering with tap water is too expensive. Due to that they just have one harvest per year. This issue described above depicts one problem discovered concerning the understanding of the whole system that watering is not necessary.

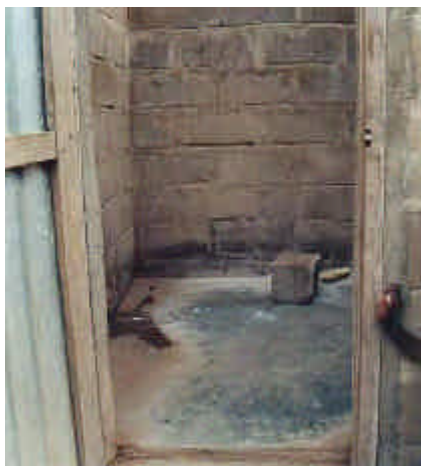
Under point 2.2.1 it was mentioned that there are three different orders of washroom and toilet room. At Youssouf Traoré the system consists of a washroom (see figure 2-17) and a toilet room (see figure 2-18) with the two holes. On the contrary to the washroom the toilet room does not have a door thus it is possible to see the right toilet hole from the courtyard. Due to this situation the toilet hole was not changed after one year as intended. In the figure 2-18 it also can be seen that one has to sit with the back towards the door when using the toilet. Also it can be seen how urine and water has flown over the concrete floor into a pipe leading it into the decanter.

Figure 2-17: Washroom of Y. Traoré

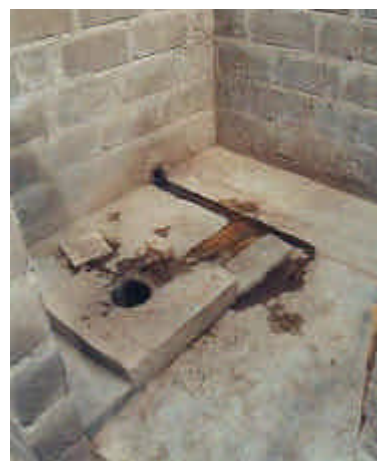
Figure 2-18: Toilet room of Y. Traoré

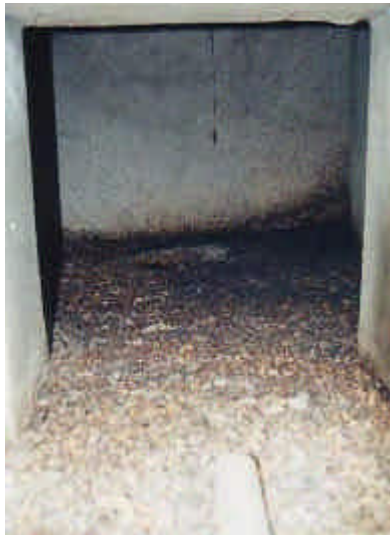
Below on the left the unused desiccation vault can be seen. On the right the vault which is used since July 2001 is shown. Even though it is used for 18 months now the vault is not full and is functioning well. No bad smell or odours are reported by the users in the toilet who are putting ash to the faeces 3-5 times a week. In the hot season there are a lot of mosquitos in the decanter and some insects in the toilet superstructure.

Figure 2-19: Unused dessication chamber

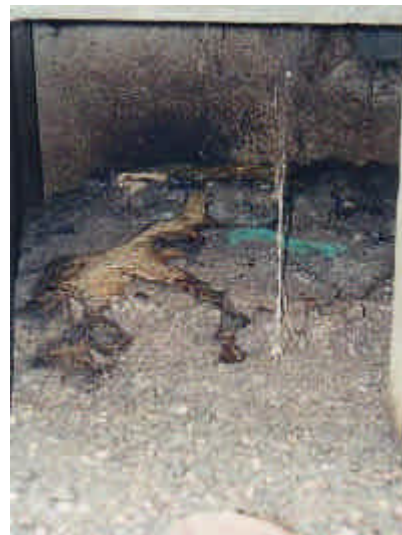
Figure 2-20: Used dessication chamber with faeces

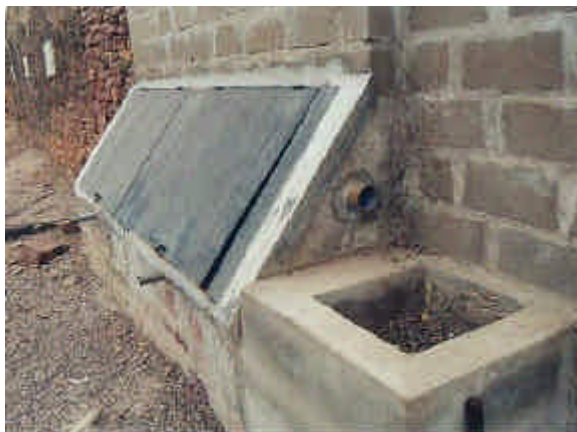
Out of economic reasons this system has no roof which leads to a surplus of water in the wastewater garden during the rainy season posing a challenge to the plants. It can also lead the overflow of the basin and of the decanter and filter units. At this site the same problem of the first metal screen is prevailing. It has been stabbed through after approximately 10 months.

Figure 2-21: Metall cleanout access door and drainage effluent chamber

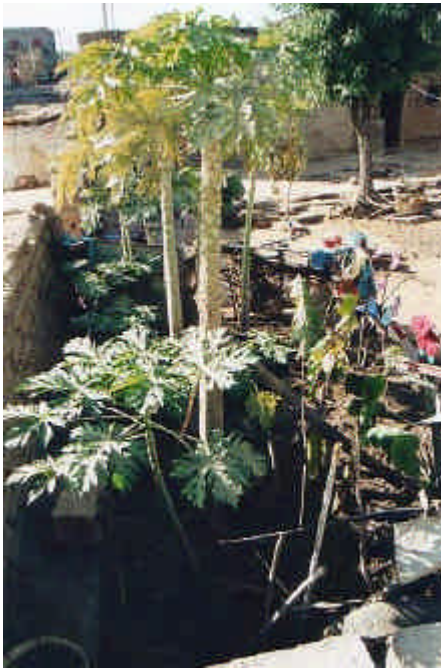
The toilet system at Soumalia Traoré is not a dessication toilet. It is a normal pit latrine where the urine is separated and lead together with the washwater into the wastewater garden. The faeces are stored in a vault which has to be emptied in the normal way. The toilet structure stayed nearly the same - one room only - with some modification for the urine separation. The decanter and filter units as well as the garden were constructed next to the toilet. The system is used by about 10 -11 persons which consume around 200 Liter per day which results in a surface load of 19.2 l/m^2 (garden size 10.40 m^2).

Figure 2-22: Wastewater garden of S. Traoré

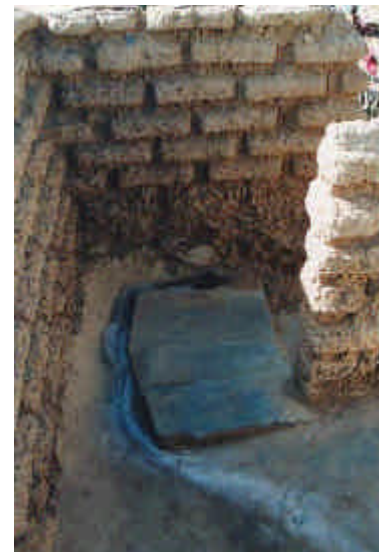
Figure 2-23: Toilet room of S. Traoré made in Banco

However, there are some problems. The toilet superstructure is made of banco (see figure 2-23) which is clay mixed with millet husks and straw. This construction material is very sensitive to rain, washing away with every new shower. In the rainy season a lot of fine clay particles together with the husks and straw is washed into the decanter, entering the gravel filter and eventually plugging the complete system. As can be seen in figure 2-22 the outer wall of the property bordering the wastewater garden is also made out of banco. During the rain banco is washed into the garden and thus destroying the Gombo shoots and clogging the soil.

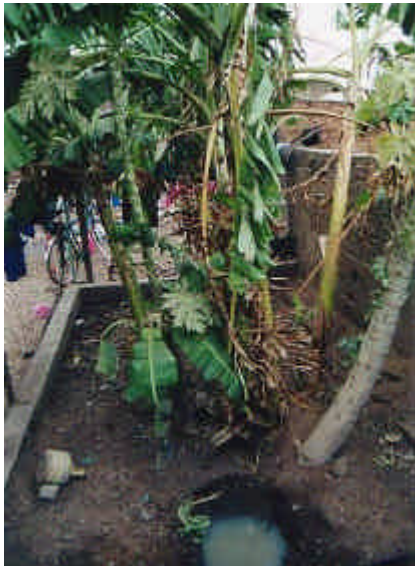
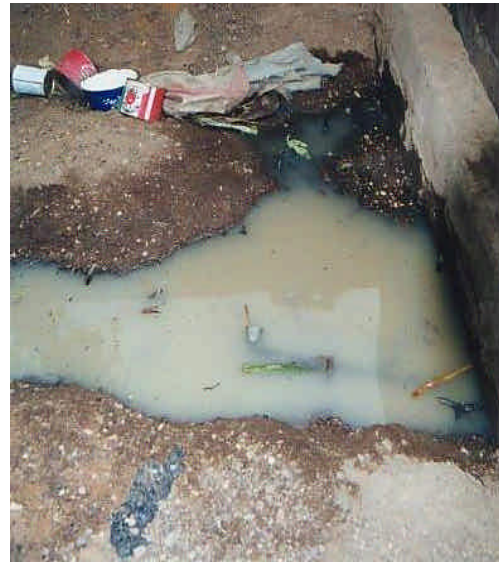
The metal screen in front of the decanter was destroyed which led to the clogging of the gravel filter. After the renewing of the filter it clogged again but no gravel was available to replace it. Now no gravel was found in the chamber. After some time it was noticed that the irrigation pipes were plugged thus one pipe was removed leading to standing water (see figure 2-25) in the garden.

Figure 2-24: Wastewater garden Fam. Koita **Figure 2-25:** Waterhole in wastewater garden

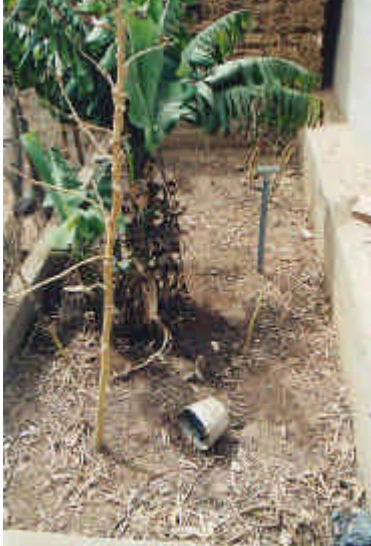
The system of a normal pit latrine and wastewater garden (8.6m²) was planned for about 25 persons. Now approximately 15 -20 are using the system which results in a surface load of about 52 l/m².

Figure 2-26: Garden at Adama Traoré

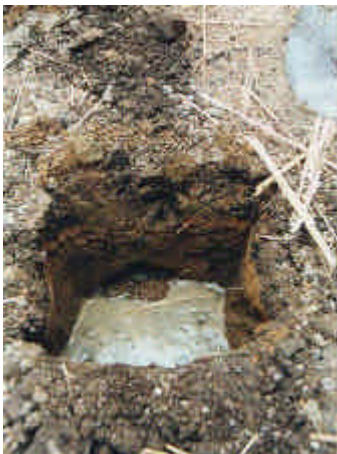
In this case two families are attached to one wastewater garden. Each of the families has their own pit latrine with urine diversion and decanter. One single gravel filter is supplied in front of the irrigation pipes. The two families add up to about 35 people using the toilet and washroom. This results in a surface load of around 58 l/m² with a garden size of 17.2 m².

Figure 2-27: Waterhole in the garden of Fam. Koné

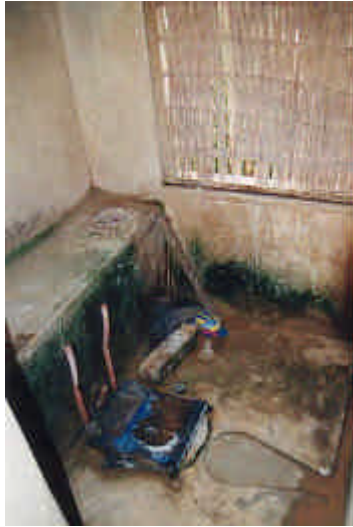
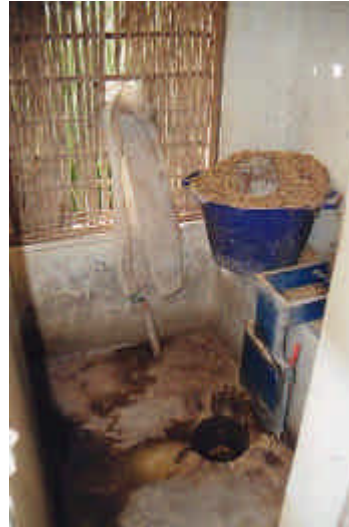
On the pictures below it clearly can be seen that the maintenance of the system is lacking thus the washroom and toilet room are dirty and mouldy. Sand in the washroom leading to the plugging of pipes.

Figure 3-1: Washing room (Yoff)

Figure 3-2: Toilet room (Yoff)

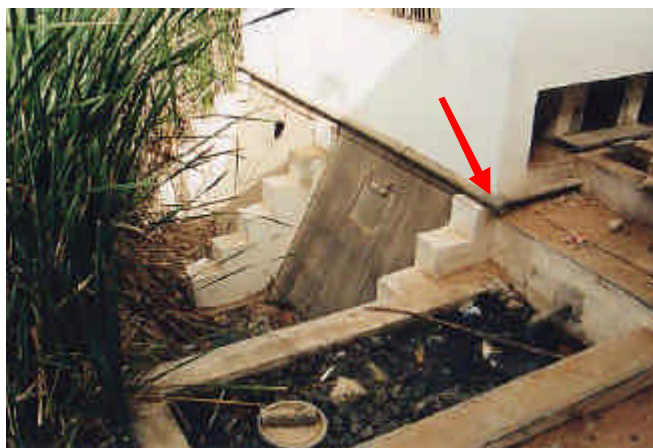
On the picture below the first basin can be seen which is totally covered with rubbish and filled with water. The maintenance work of degreasing the decanter as well as cleaning the filter cloth has not been accomplished therefore leading to the clogging and eventually to an overflowing bucket. This water which is saturated with grease, soap, sand and other objects finally lead to the clogging of the gravel resulting in water resting in the basin. Many mosquitos and mosquito larvae were noticed in the water accompanied with a bad smell. In order to improve the situation but without cleaning the system the cap (marked by the arrow) of the pipe leading to the decanter was removed. Now the shower water and the urine flows directly into the basin. On this picture it also can be seen that the missing maintenance respecti vely cutting of the typhus plants lead to a shadowing of the metal doors.

Figure 3-3: First basin and metal cleanout acces door of the ecosan system

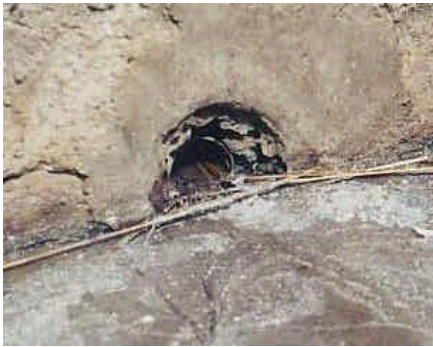
In all of the installations the first metal screen in front of the decanter was oxidised (see figure 3-4) so that the holes were blocked and eventually the screen was stabbed. Because of this removal of the screen foreign substances such as sand, hair and residues from the natural sponge were able to enter the decanter and gravel filter leading to the blockage. One solution for this problem which was implemented in some installations is the replacement of the metal screen with a selfmade plastic screen which is shown in figure 3-5.

Figure 3-4: Oxidised metal screen

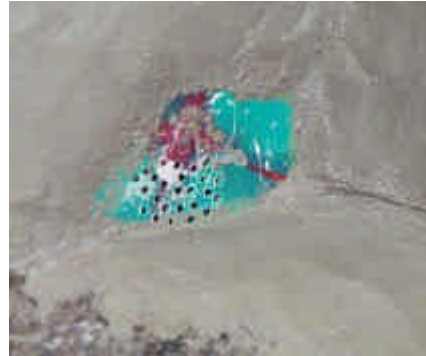
Figure 3-5: New plastic screen

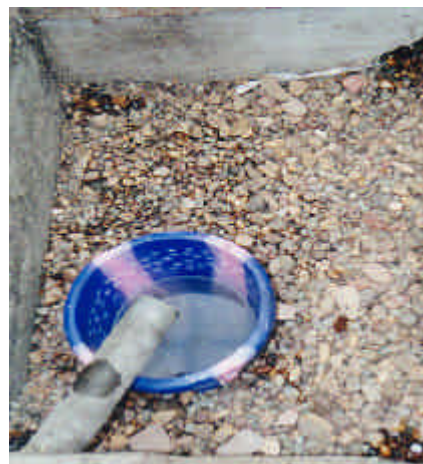
Figure 3-7: Photo of gravel filter with decantation / filter bucket

A second measure to improve the situation has been implemented in the families of F. and A. Koné, A. Traoré and Y. Traoré. After the emptying of the old gravel and charcoal, new gravel which was either collected on the street or washed was filled in the chamber as depicted in the figures 3-6 and 3-7. With the implementation of the perforated buckets in the gravel bed solids passing the decanter can settle in the lower part of the bucket while the water enters the gravel bed via the holes in the upper third. This system leads to a second decantation, even distribution of the water over the gravel and an easy emptying of the solids entering the bucket.

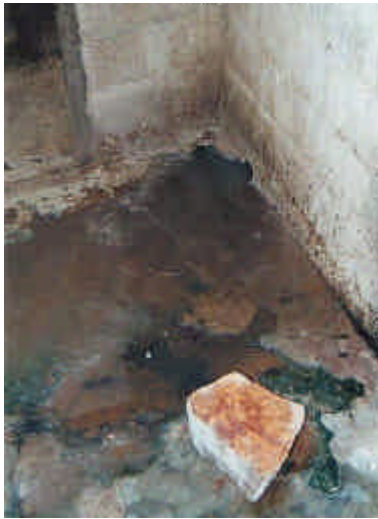
Figure 3-8: Extensive concrete corrosion

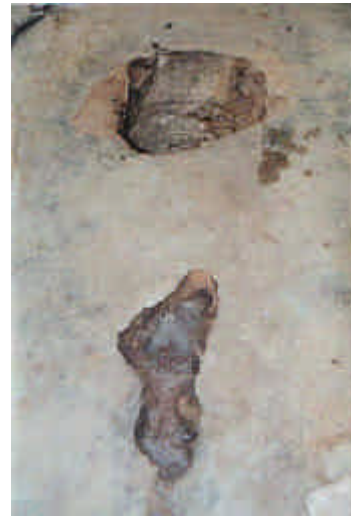
Figure 3-9: Local concrete corrosion

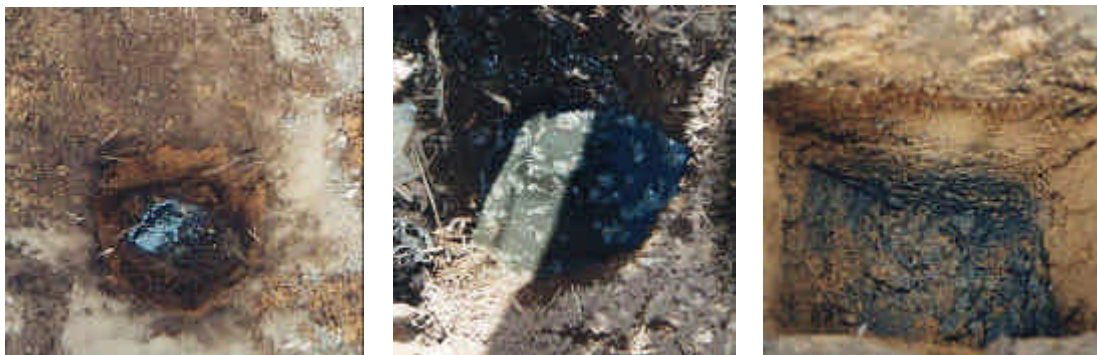
One problem mentioned above is the belief that there is no water in the garden and that they have to water the plants in the dry season like the normal farmers. This is due to the fact that they can not see the water under the dry surface. In all of the gardens holes were dug to show that water is available all year-round (see figure 3-10). In some gardens water was standing in some 10-35 cm under the surface like groundwater (see also figure 2-27) and in other gardens the soil was wet.

Figure 3-10: Examples of waterholes in the wastewater gardens.
