1 General data

Rural upgrading

In total 42 UDD toilets (East Hanahai: 5 households, West Hanahai: 5 households, Paje: 11 households initially, expanded to 32 households)

The overall goal of this ecosan project (which was a component of a larger program called CBNRM, see Section 4) was to develop, test and demonstrate a holistic/integrated approach to environmental management, sanitation and waste management at the household and community level in selected communities.

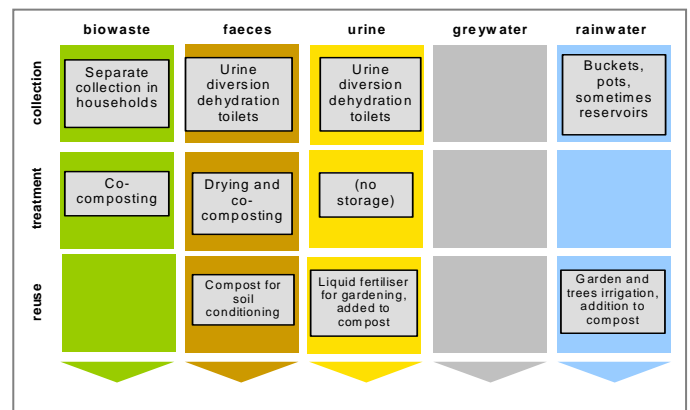
Fig. 2: Applied sanitation components in this project

The communities were informed about three different types of “ecosan toilets”, namely urine diversion dehydration toilet (UDDT), Arborloo, and composting toilet. The households chose the UDDT to be the most feasible solution. An initial design was taken from a South African model and then adapted over the course of implementation. Essentially a single vault UDDT was used with a container inside of the faeces vault.

The urine was collected in a container situated within the vault or outside and was available for reuse. The system was complemented by a composting unit for processing and hygienising the faecal matter that was emptied out from the collection chamber. The faecal matter was composted together with other household organic waste and animal refuse. Urine was added regularly to the compost heap.

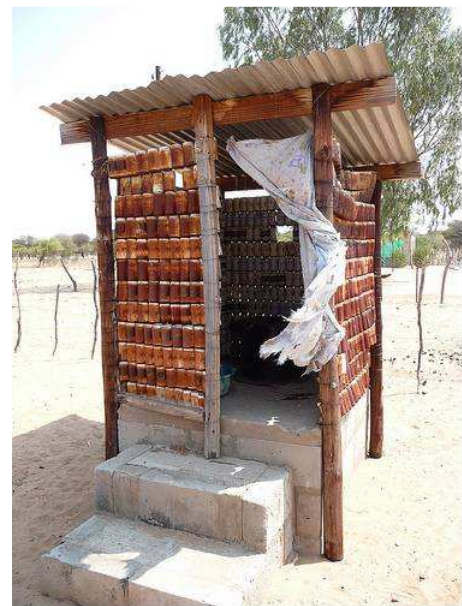
Fig. 5: Ecosan UDD toilet built out of beer cans in Hanahai. The most creative superstructure in the region!

Households were responsible for constructing the super-structure and they used different materials, such as stone, wood, shade nets, even beer cans (see photo below).

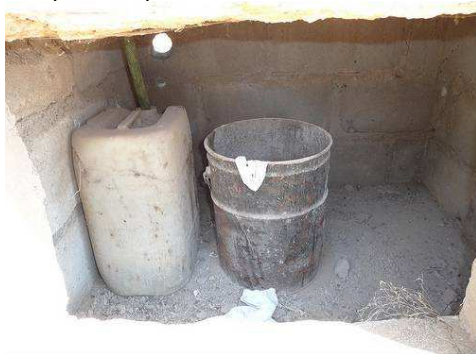
Fig. 6: Collection chamber under a properly working ecosan UDD toilet (left: urine container, right: faeces bucket) in Paje.

Faeces collection chamber: Faeces were collected in 50 L buckets or as heaps. It was recommended to add one cup from a mixture of ash and sand after every defecation to reduce the humidity of the faeces, flies and odour. A family of two adults and four children needed 2 - 3 months to fill a 50 L bucket, and this was then emptied onto the compost unit. Some families started using smaller 20 L buckets that needed to be emptied more often (once a month), but were lighter and thus easier to handle even by one person alone.

Urine collection: Urine was collected in a 20 L container placed either inside the chamber or outside next to it. Cooking oil containers, available almost anywhere in the country were used for this. One was filled by the "average family" mentioned above in about three weeks; however, the filling

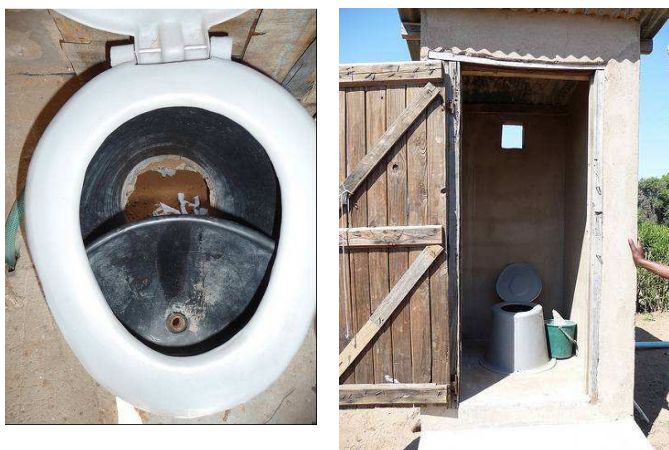
Fig. 7: Left: UDD toilet working properly in West Hanahai. Right: This UDDT was well maintained, ash standing next to the toilet and composting unit filled (in Paje).

During the visit in 2009, it was observed that the UDDTs with above ground chambers were working well. In two cases in East Hanahai, the below ground structure was still in use, but the removable concrete slab had been permanently removed to facilitate maintenance. UDDTs which were later abandoned included however both those with below ground structures and those built entirely above ground.

For the UDDTs still in use, the maintenance of the toilets was adequate in all cases. The toilets appeared to be clean and almost odourless. All households had a bowl of sand or ash standing next to the toilet. In most cases, a small 20 L bucket was being used for collecting the faeces, and plastic bags were used as gloves when emptying the buckets. Families reported that it took 1½ to 3 months to fill the bucket, depending on the number of people and the size of the bucket.

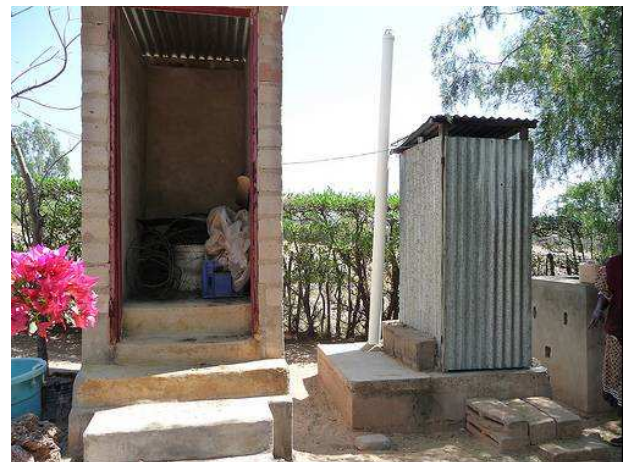
Fig. 9: UDDT next to pit latrine (where, Paje or Hanahai?). The UDDT was never used since its installation in 2004 (as the main female of the household objects to having to empty the faeces container. The pre-existing pit latrine is used instead. (what happens when pit latrine is full?).

In Paje, those families that already had pit latrines were not motivated to maintain a UDDT in the long-run. In all cases where two toilets were found on the same plot, the pit latrine was used and family members said that they either did not know how to handle the faeces and/or considered it to be 'yucky'. The parallel structures seem to account for an unwillingness to maintain the UDDT, in some cases because the decision to make a new toilet had not been taken by the woman who usually maintained the UDDT.
